Petition PE1236 – A90 Laurencekirk junctions

A90 LAURENCEKIRK ROAD SAFETY REVIEW

09/NE/0805/138

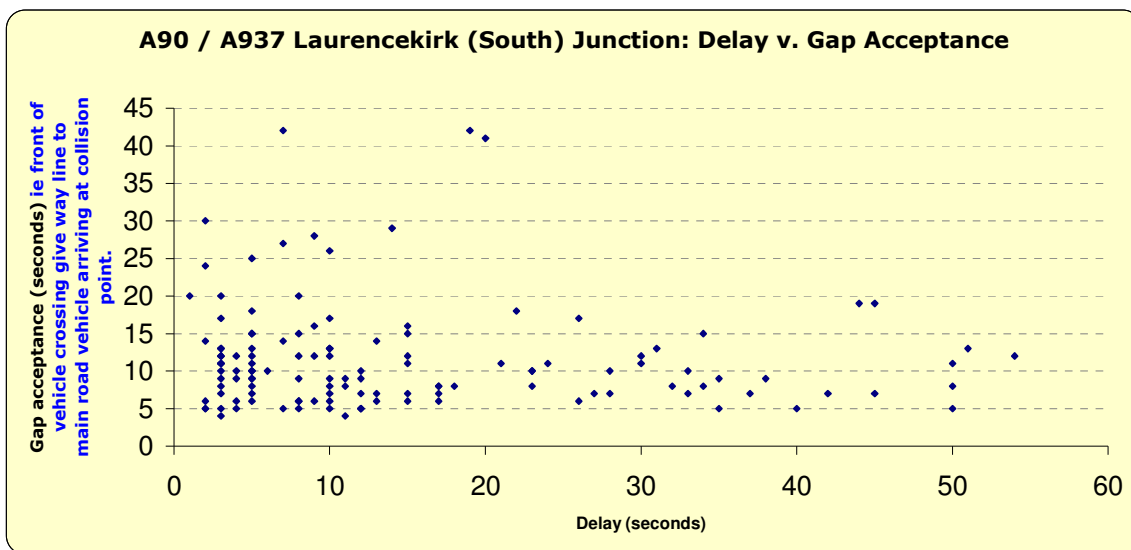
7.17 Figure 7.1 also indicates that gap acceptance times at this junction are generally between five and twenty seconds. Table 7.4 shows the numbers of vehicles accepting a gap of five seconds or less. Whilst there are a fairly large number of vehicles accepting a five second gap, there are only two who accepted a smaller gap. This indicates that despite the sometimes lengthy delays at this junction, risk taking by drivers is low.

Figure 7.1 – A90/A937 South Junction - Delay against Gap Acceptance

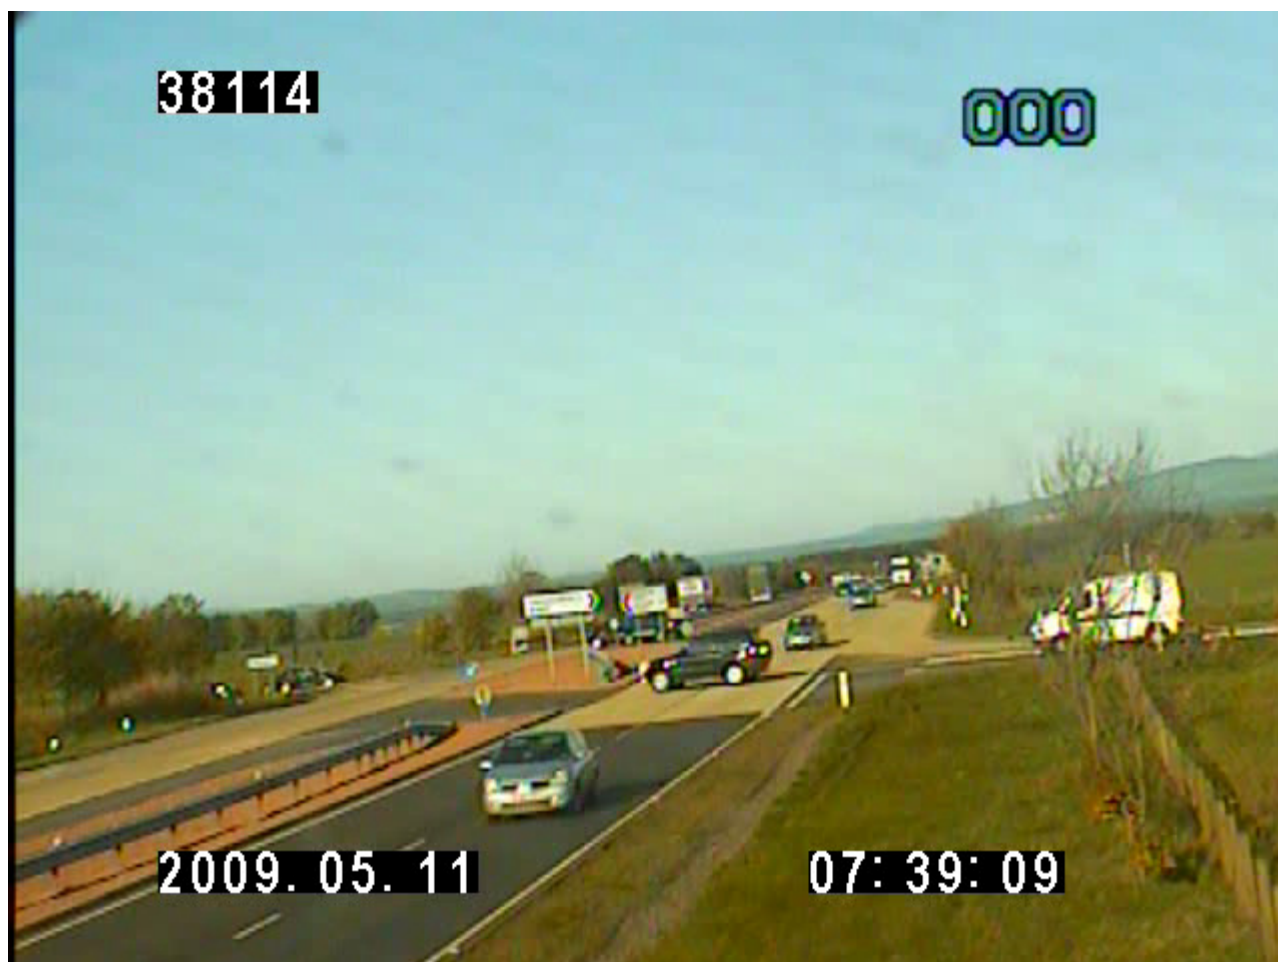
7.18 The A90 Laurencekirk Traffic Survey Report concluded that right turning movements from both side roads were highlighted as conflicts. This is consistent with the recorded injury and damage only accidents at this junction. A typical conflict scenario at this junction is shown in Picture 7.1

Picture 7.1 Example of Predominant Conflict at the A90/A937 South Junction involving Right-turners from Laurencekirk and A90 Northbound Traffic

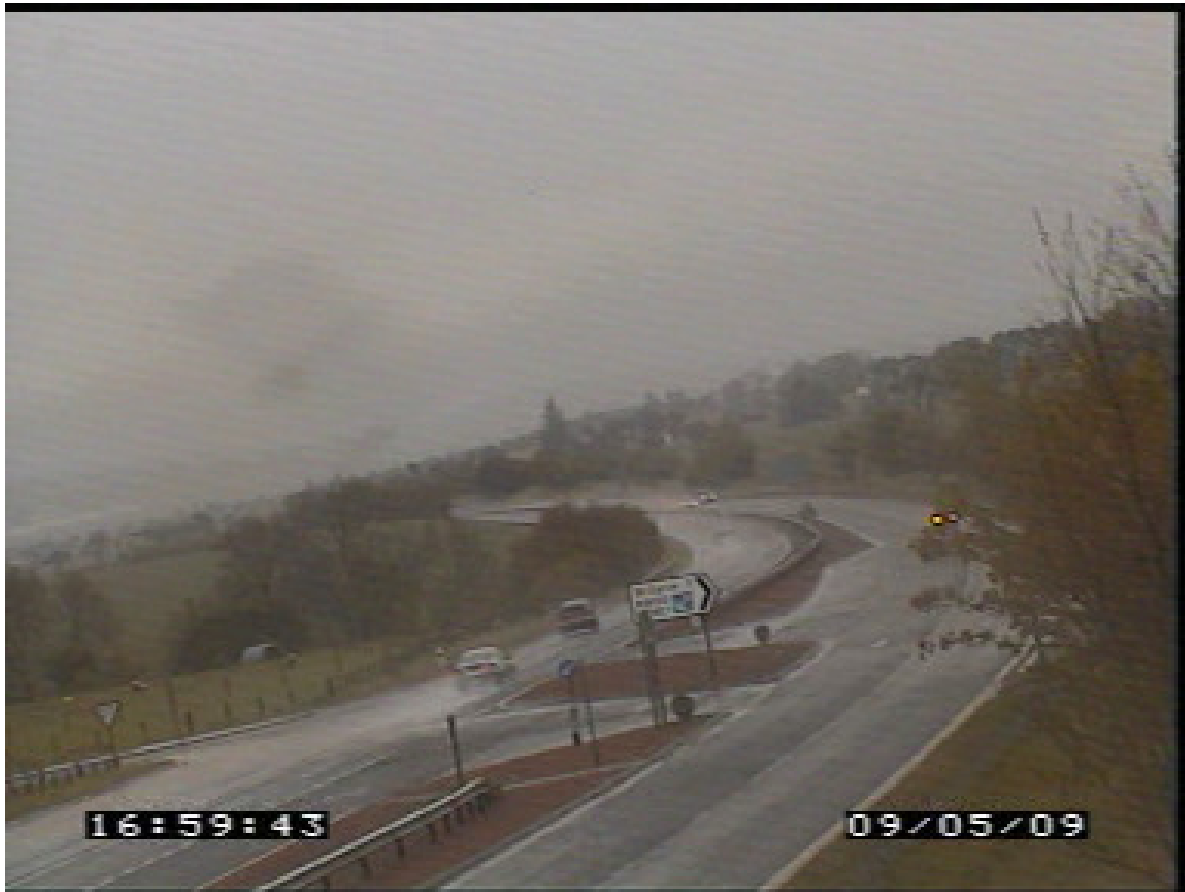
7.28 The Traffic Survey Report concludes that the predominant conflict manoeuvre is the left turn from the northwest leg onto the northbound A90. However, this is not reflected in the accident statistics, which records only one damage only accident involving a left turn movement from 2006 to 2008. A typical conflict scenario at this junction is shown in Picture 7.2

Picture 7.2 Example of Predominant Conflict at the A90/B9120 Junction involving A90 Northbound Traffic Braking and Changing Lanes to Accommodate Left-turners from Laurencekirk

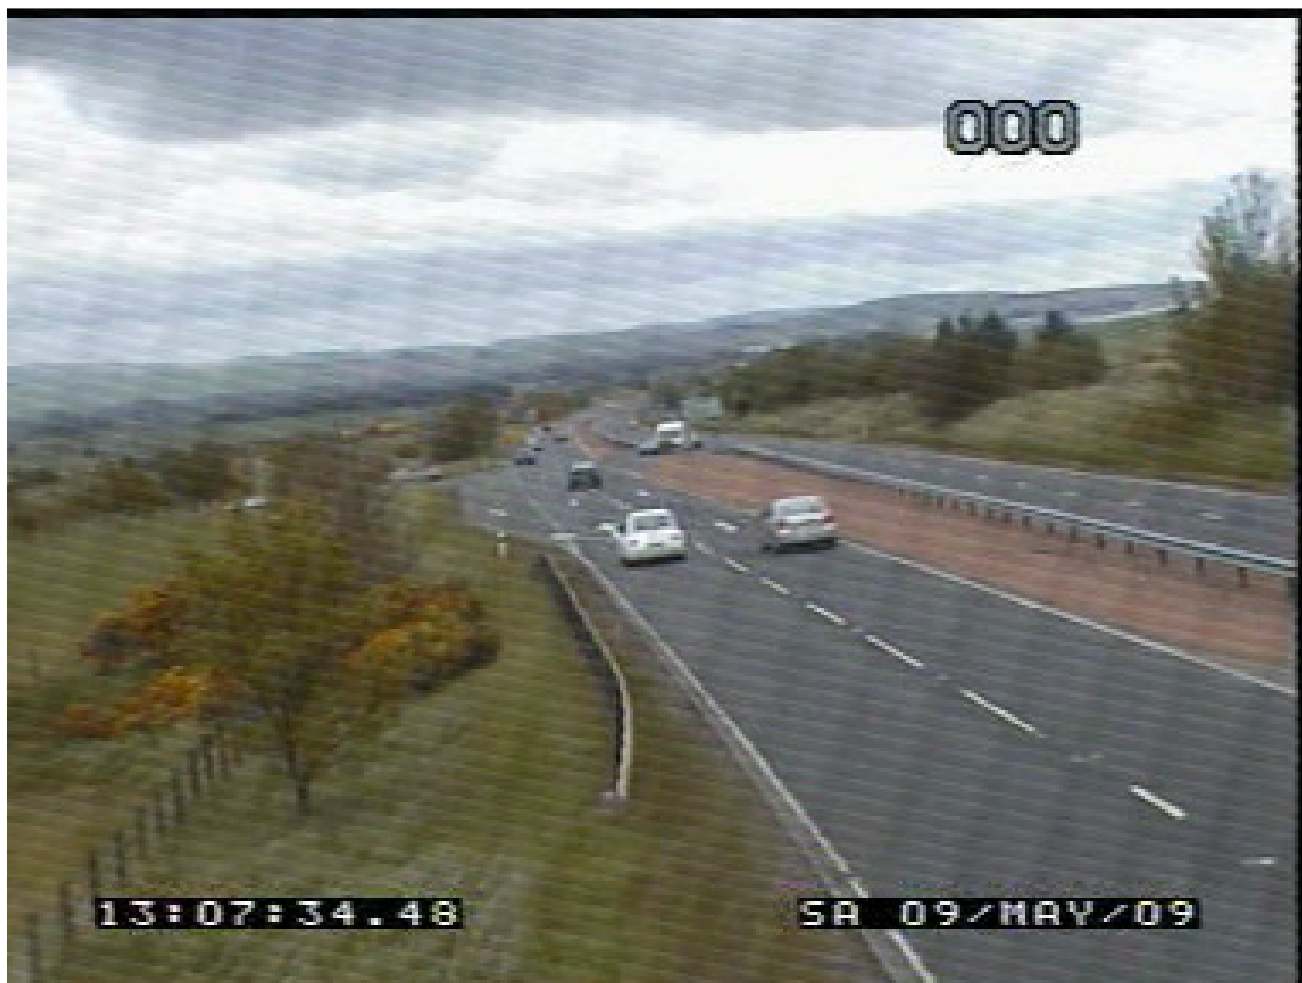
Picture 7.3 Example of Predominant Conflict at the A90/A937 North Junction involving A90 Northbound Traffic Braking and Changing Lanes to Accommodate Left-turners from Laurencekirk

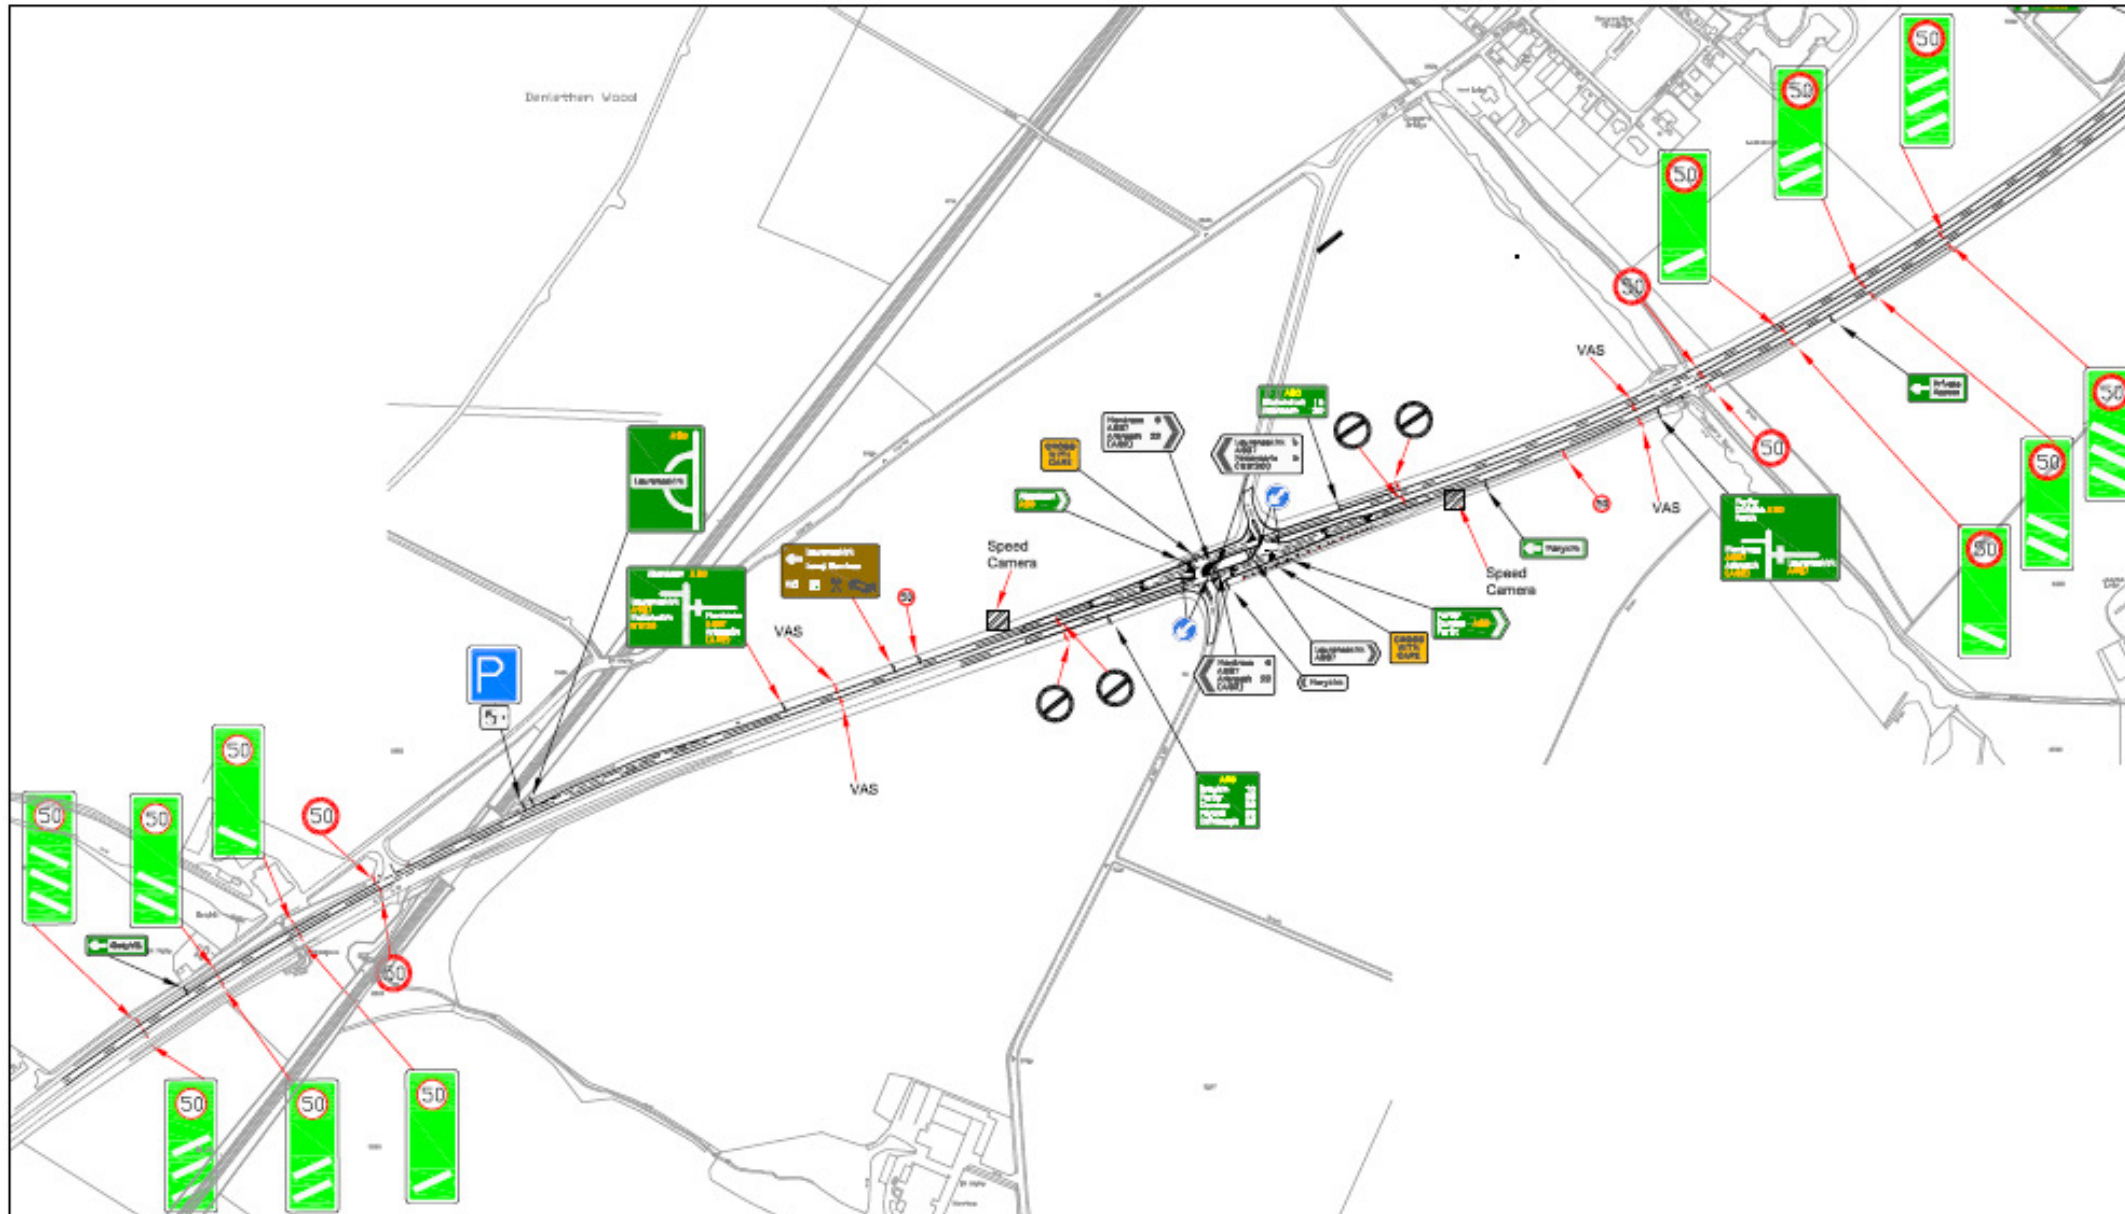
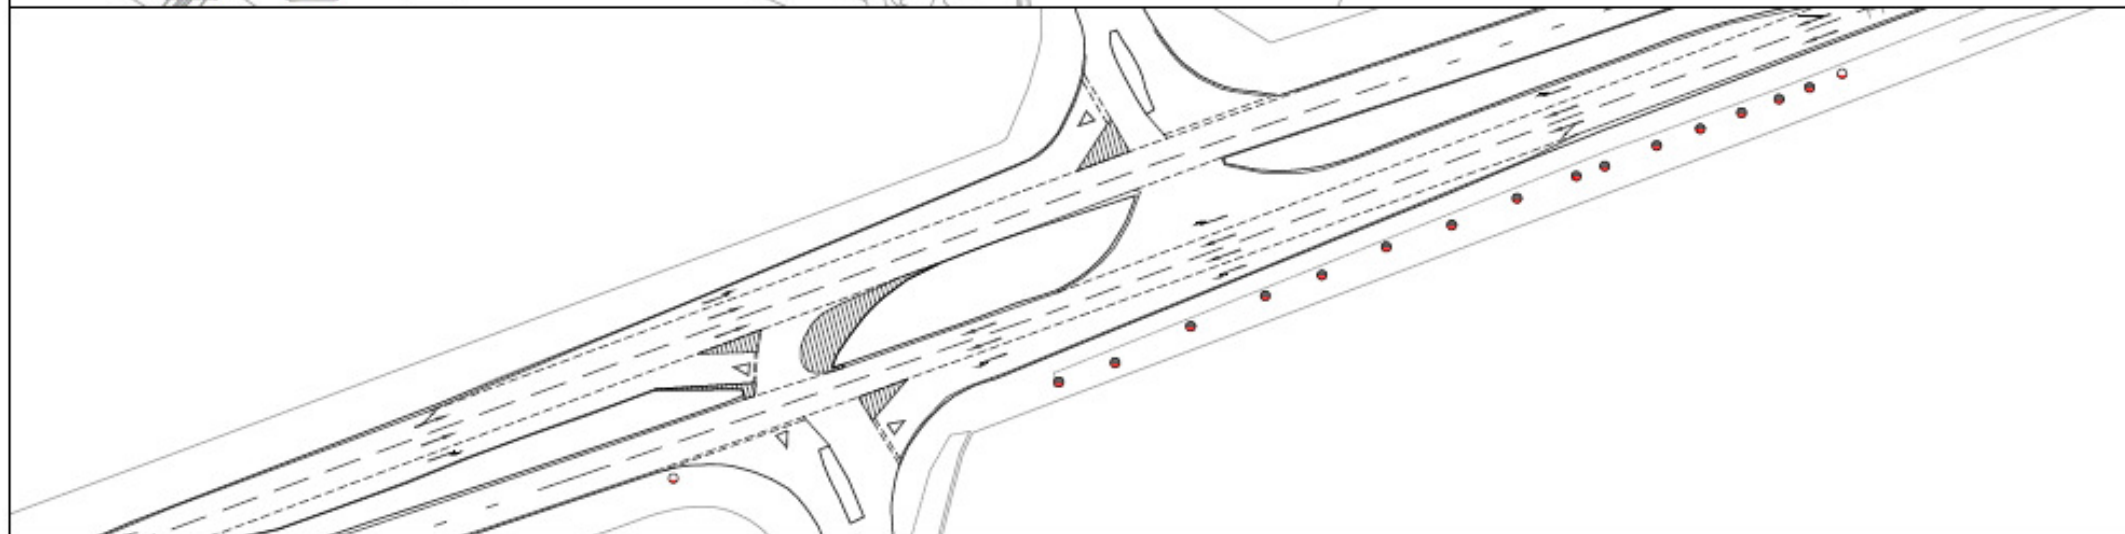
Drawing Number: 09/NE/0805/138

- 3.17 Whilst the road markings at this junction appears to be in generally good condition, a road marking condition survey for the A90, carried out in October 2008, identified that the line reflectivity in this area is generally below the suitable level. In addition, it was noted during the site visit that a number of road studs were missing at this junction.

- 3.41 Whilst road markings at this junction appears to be in generally good condition, a markings condition survey for the A90, carried out in October 2008, identified that the line reflectivity in this area is generally below a suitable level. In addition, it was noted during the site visit that a number of road studs were missing in the general vicinity of this junction.
- 3.42 Signing at this junction is generally in good condition, as shown in the photographs contained in Appendix C.
- 3.43 Details of the existing road marking and signing provision for this junction are contained in Appendix G

- 9.7.11 In order to address the reflectivity issue with the existing lining, as mentioned in section 3, it is proposed that the existing lining at all three junctions is refreshed. The opportunity should also be taken to replace all existing road studs at these locations with high visibility studs that use microprismatic faces, to further highlight the junctions.
