PE1236/AA

Subject: Letter for consideration with Petition PE1236 in the name of Jill Campbell

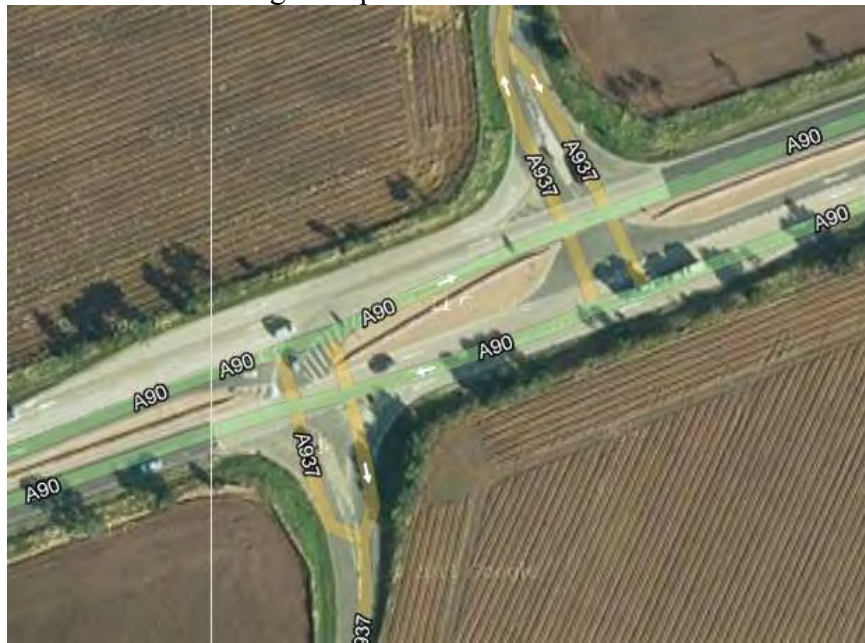
Image of the location from Google Maps

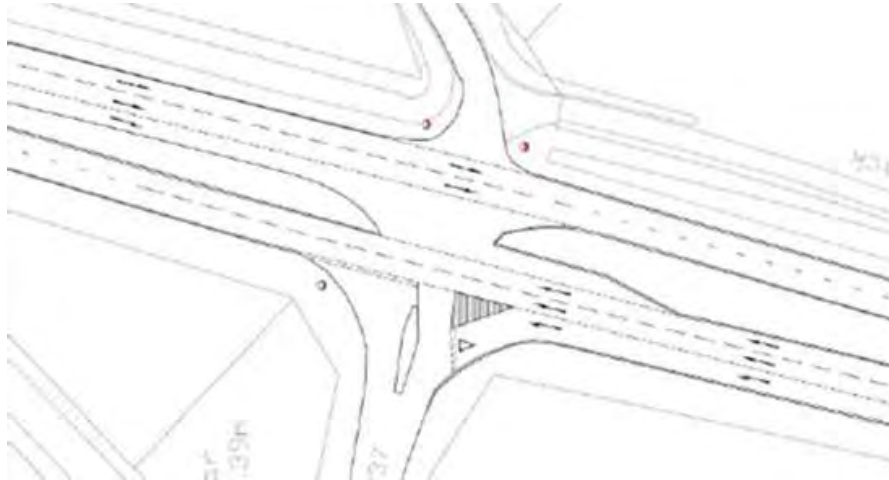
Location 1

The most likely cause of accident is an over-speeding car colliding into the vehicle waiting to enter A90 or a car could have stopped on A937 Montrose side leg and the following car could have collided into it.

- Considering that it is quite a sharp curve, the possible recommendations could be to widen the curve to allow the drivers to reduce speed and then enter the A90 road given that the turning lane is already protected.

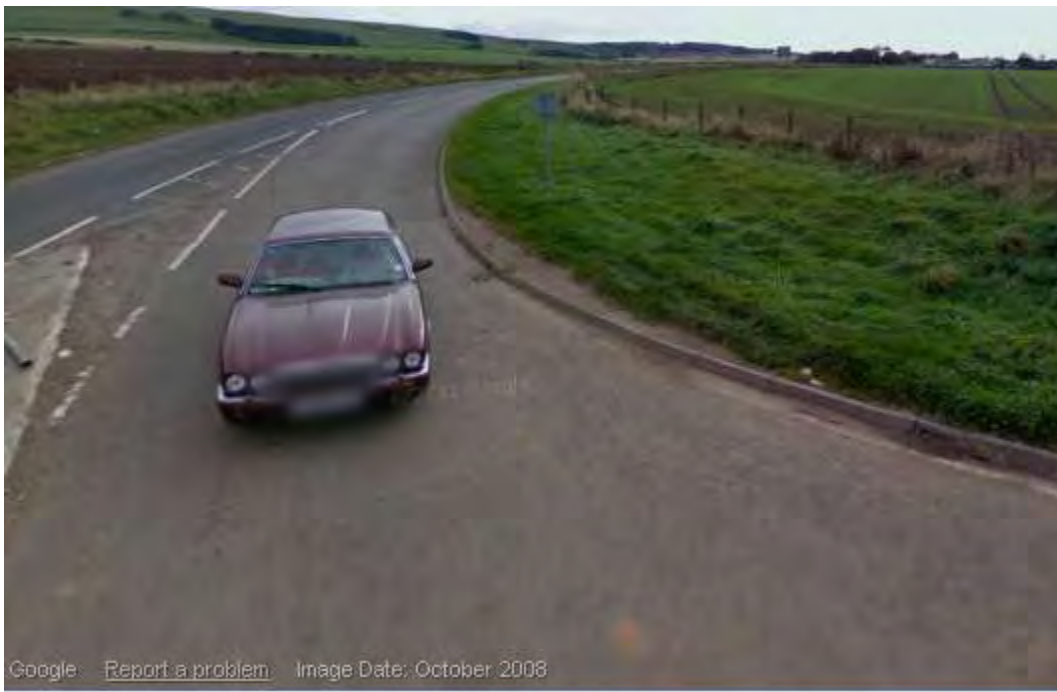
It is equally possible that the shadow from such vegetations may „hide“ the vehicle from the incoming traffic.

- The vegetation could be reduced and a hard-shoulder could be allowed for vehicles which break-down and used when traffic volumes may increase.

- The center line curve on the A937 Montrose side is not helpful for people who are wishing to travel to the on Laurencekirk side.
- A speed limit may be posted at the site

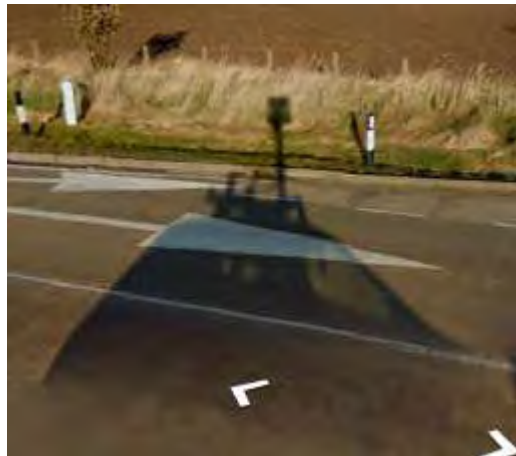
The high number of accidents at this location may be due to the weaving of the traffic at the protected turning to the A937 on Laurencekirk side. It's surprising to see that the traffic study detailed in the picture in PE1236/E page 73 does not include the protected turning lane in the design diagram and analysis. This could have missed the opportunity to consider the conflicts that would occur at this site.

There is not enough space to allow the driver to change lane. The only way is that the drivers keep a distance and maintain speed which will cause accidents

- Contrary to the junction on the Montrose side, it can be seen the curve is quite easy and will allow the driver to reduce the speed and enter the road A937 on the Laurencekirk side. The only issue seems to be the speed at which the cars seem to enter the A937. The need is to post a speed limit.

- The protected learning lane needs to be extended to ensure that the drivers have enough time to reduce their speed and accommodate for the preceding car and enter the curve
