Petition PE1236 – A90 Laurencekirk junctions

A90 LAURENCEKIRK ROAD SAFETY REVIEW

09/NE/0805/138

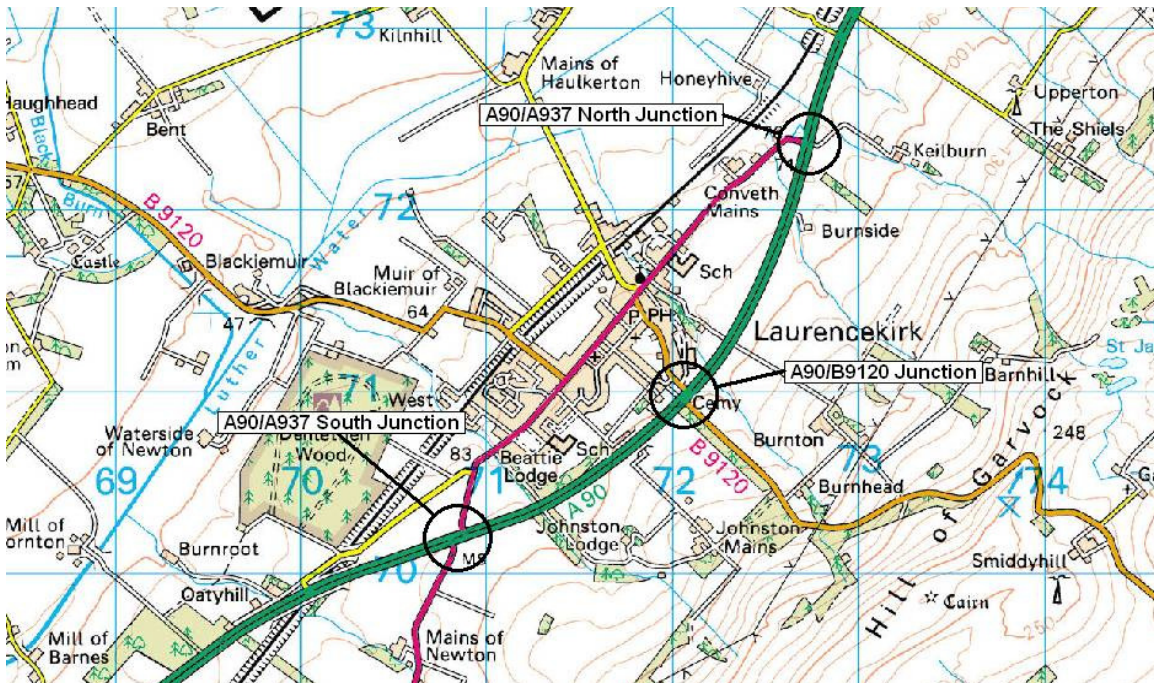
Figure 3.1 - Location of A90 Junctions in the vicinity of Laurencekirk

- 3.35 The A937 is the main route, which runs through the centre of Laurencekirk. The A937 meets the A90 trunk road at two junctions one to the southwest (which has been discussed in section 3.2) and one to the northeast. The locations of the junctions at Laurencekirk are shown in Figure 3.1.

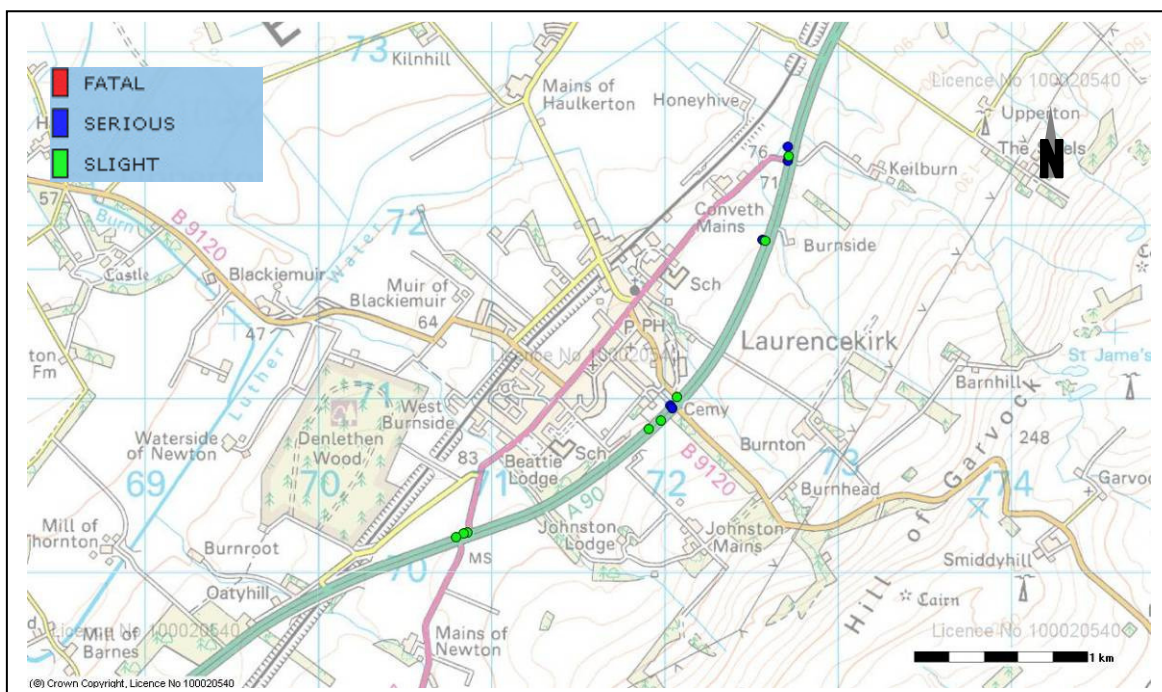
Figure 5.1 – A90 Laurencekirk Injury Accident Plot 2006 to 2008

- 5.1 SERIS accident details for the A90 covering the three junctions in question from January 2006 to December 2008 were obtained. These record thirteen injury accidents; six serious and seven slight injury accidents and seventeen damage only accidents within this section. Fig 5.1 shows the spread of injury accidents over the three year period. Table 5.1 provides an annual total of all accident types.

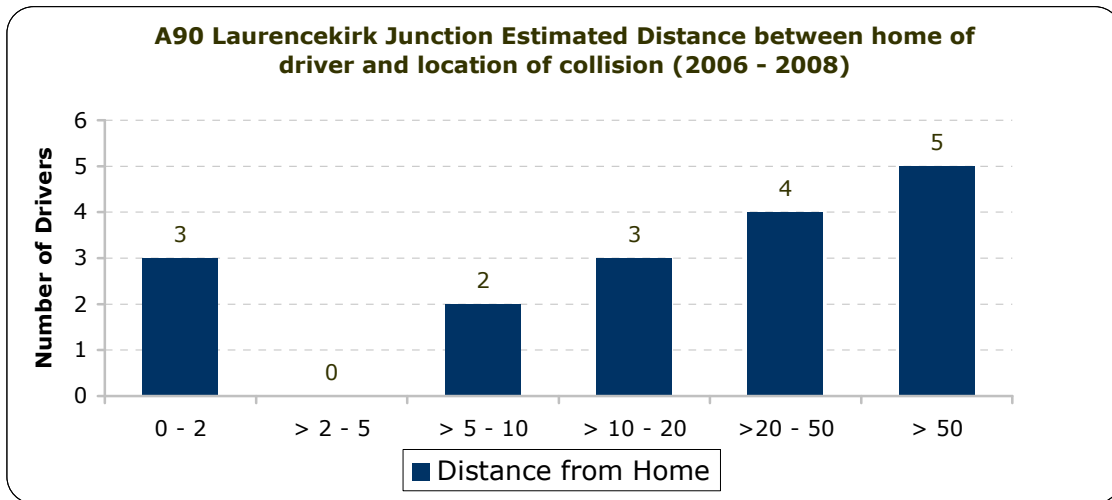
Table 7.1 – A90 Laurencekirk Estimated Distance between Driver Address and Collision Location

- 7.9 Excessive or inappropriate speed was not recorded as a contributory factor in any of the injury or damage only accidents.
- 7.10 As shown in Table 7.1 30% (five) of the drivers involved live within 10miles of Laurencekirk. The spread of data displayed in this table is indicative of the strategic and local functions of the A90 route at this location. The values shown in Table 7.1 also indicate that the general layout of this section is clear to those unfamiliar with the area. Had this not been the case then a more prominent spike towards the greater distances would be expected.

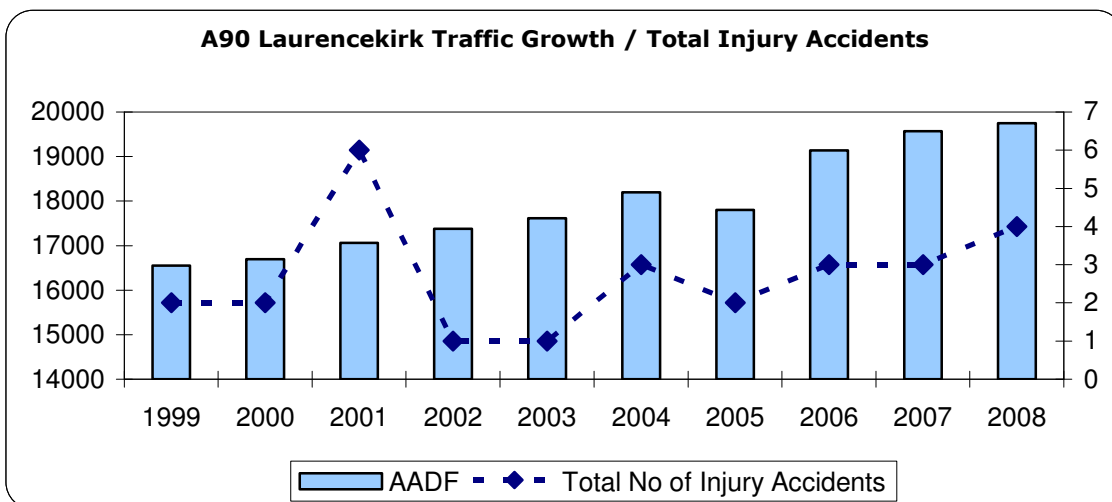
Table 7.2 – A90 Laurencekirk 10 year Traffic Flow Data / Junction Injury Accident Data

7.8 Table 7.2 indicates that the combined injury accident frequency for the three junctions over the past ten years has remained fairly steady, with the exception of the spike in 2001. This is despite a growth in traffic flows of approximately 19% in traffic over this period. The mean accident frequency over this period is 2.6 accidents per year in comparison to 3.3 for the most recent three year period. However, this slight increase in accident numbers is not statistically significant given the relatively low figures being analysed.

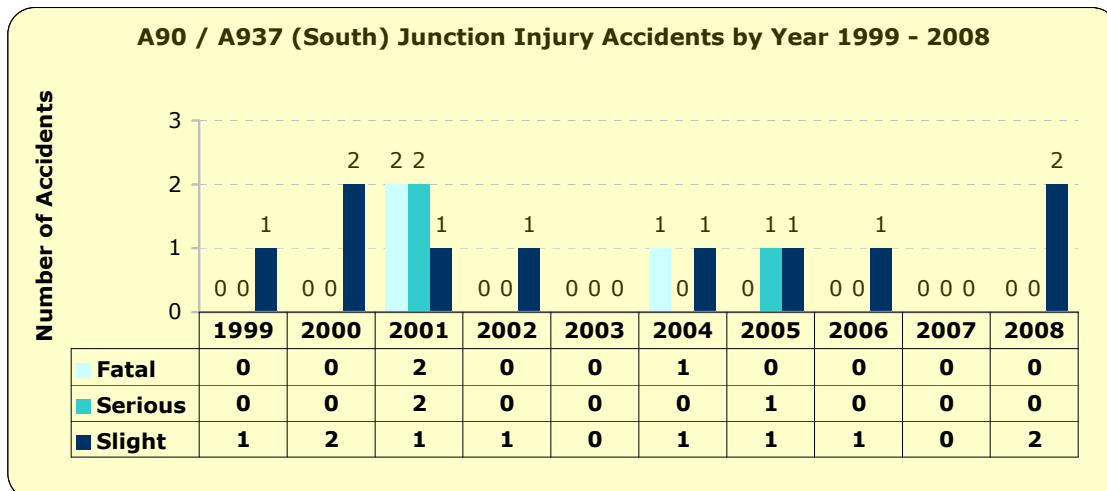
Table 7.3 – A90/A937 Laurencekirk South Junction 10 year Accident

- 7.9 Three injury accidents have occurred at this junction over the period 2006 to 2008. Two of these accidents involved right turning manoeuvres;
- Two slight (86 year old male driver and 32 year old female driver)
- Two of the seven recorded damage only accidents involved a right turning movement.
- 7.10 All three injury accident occurred on the northbound carriageway.
- 7.11 All three injury accidents within this period occurred in daylight.
- 7.12 Two of the injury accidents occurred on a wet/damp road surface.
- 7.13 Two of the injury accidents at this junction involved skidding. However, one was due to oil on the road surface. The second accident was in wet/damp weather.
- 7.14 Table 7.3 indicates that the accident frequency over the past ten years has remained fairly steady, with the exception of the spike in 2001.

- 7.15 Whilst the overall numbers of accidents have not reduced at this junction there has been no serious or fatal injury accidents recorded since the introduction of the 50mph speed limit at this location in 2005.
- 7.16 Figure 7.1 contains a scatterplot of the gaps accepted by drivers in comparison to the delay they encountered when attempting a crossing or merging manoeuvre during peak flow periods. Figure 7.1 shows that there is a wide spread of delays at this junction up to a maximum of about 55 seconds. The reason for this may be the bunching effect that a camera enforced lower speed limit at this location has on trunk road close following behaviour. When entering the 50mph speed limit, vehicles will naturally bunch up, resulting in a shorter gap between vehicles.

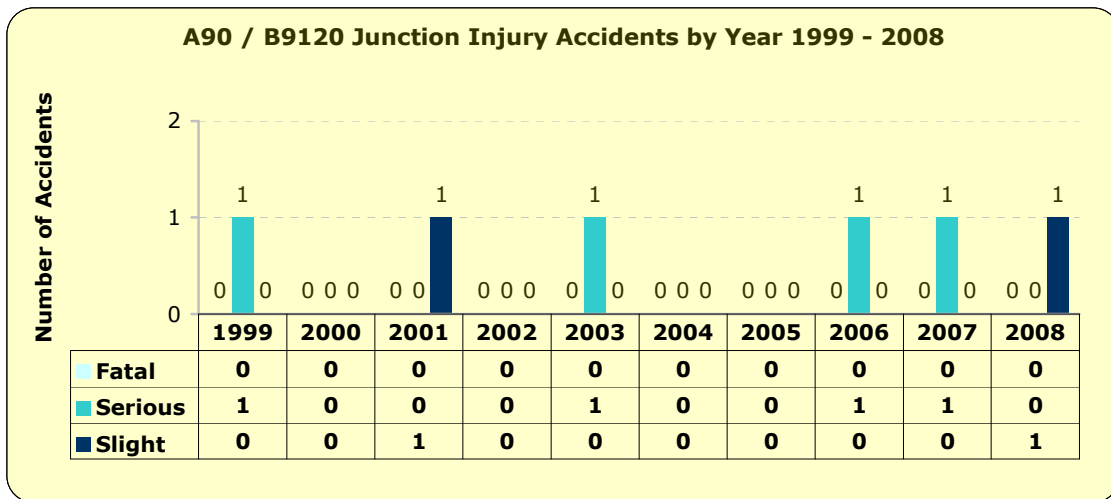
Table 7.5 – A90/B9120 Junction 10 year Accident Data

7.25 Table 7.5 indicates that the accident frequency over the past ten years has been sporadic, with no more than one accident occurring in any year. The average annual accident rate over this period is 0.6. This rate has increased to one per year in the past three years. However, given the low accident numbers being considered, this is not a significant increase, equating to one additional accident over the latest three year period.

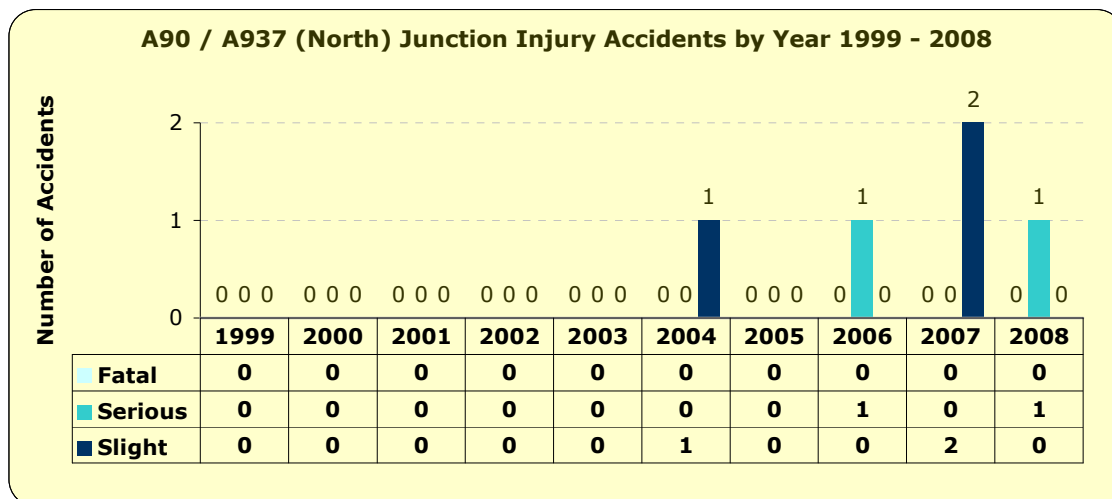
Table 7.7 – A90/A937 North Junction 10 year Accident Data

- 7.33 Table 7.7 shows an increased injury accident frequency at this junction in recent years. No injury accidents were recorded from 1999 to 2003, however five have occurred since then. No change in junction layout or operation has been identified to explain this. However, due to the low accidents numbers and short time period over which these have been recorded, it is unclear whether this is an emerging pattern or a random variation.

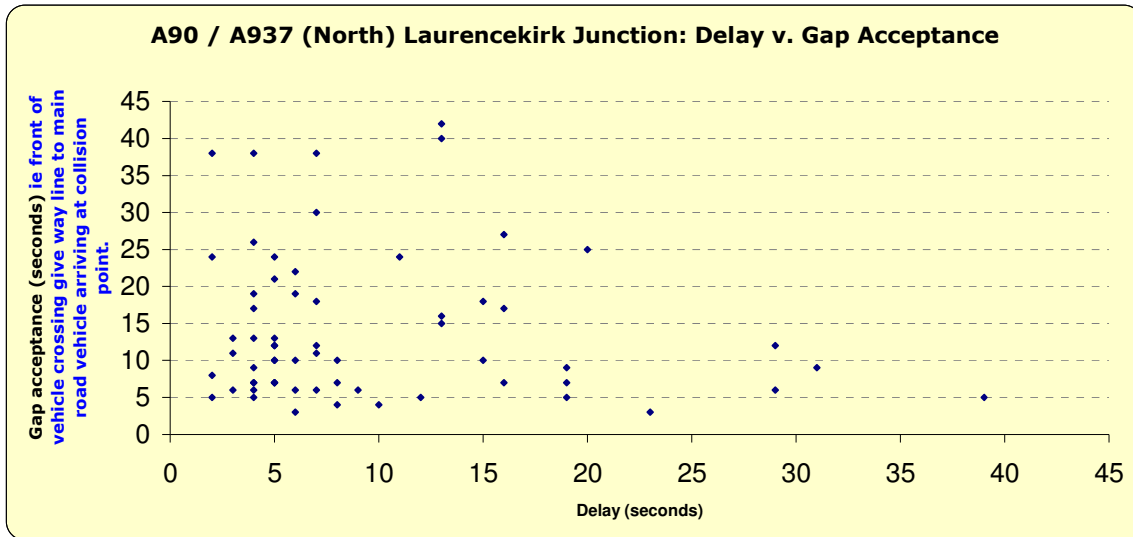
Figure 7.3 – A90/B9120 Junction - Delay against Gap Acceptance

- 7.34 As with the A90/B120 junction Figure 7.3 indicates that delays to crossing/merging traffic are relatively low, with the majority of delays recorded below 25 seconds.
- 7.35 It would also appear from the vertical spread of values in Figure 7.3 that there are longer gaps available to traffic. Consequently, it is surprising to find in Table 7.8 that gap acceptance of four seconds and below is higher than the other two junctions.
- 7.36 The Traffic Survey Report identifies the predominant conflict manoeuvre is the left turn from the west leg onto the northbound A90. However, this is not reflected in the accident statistics, which records no injury or damage only accidents involving a left turn movement from 2006 to 2008. A typical conflict scenario at this junction is shown in Picture 7.3
